US Army Corps  
of Engineers  
Construction Engineering  
Research Laboratories

Technical Report REMR-OM-19  
June 1997

# REMR Management Systems—Navigation and Flood Control Structures, Condition Rating Procedures for Lock and Dam Operating Equipment

by *James H. Stecker, Lowell F. Greimann, Scott Mellema, and Kevin Rens*  
*Department of Civil and Construction Engineering*  
*Iowa State University*

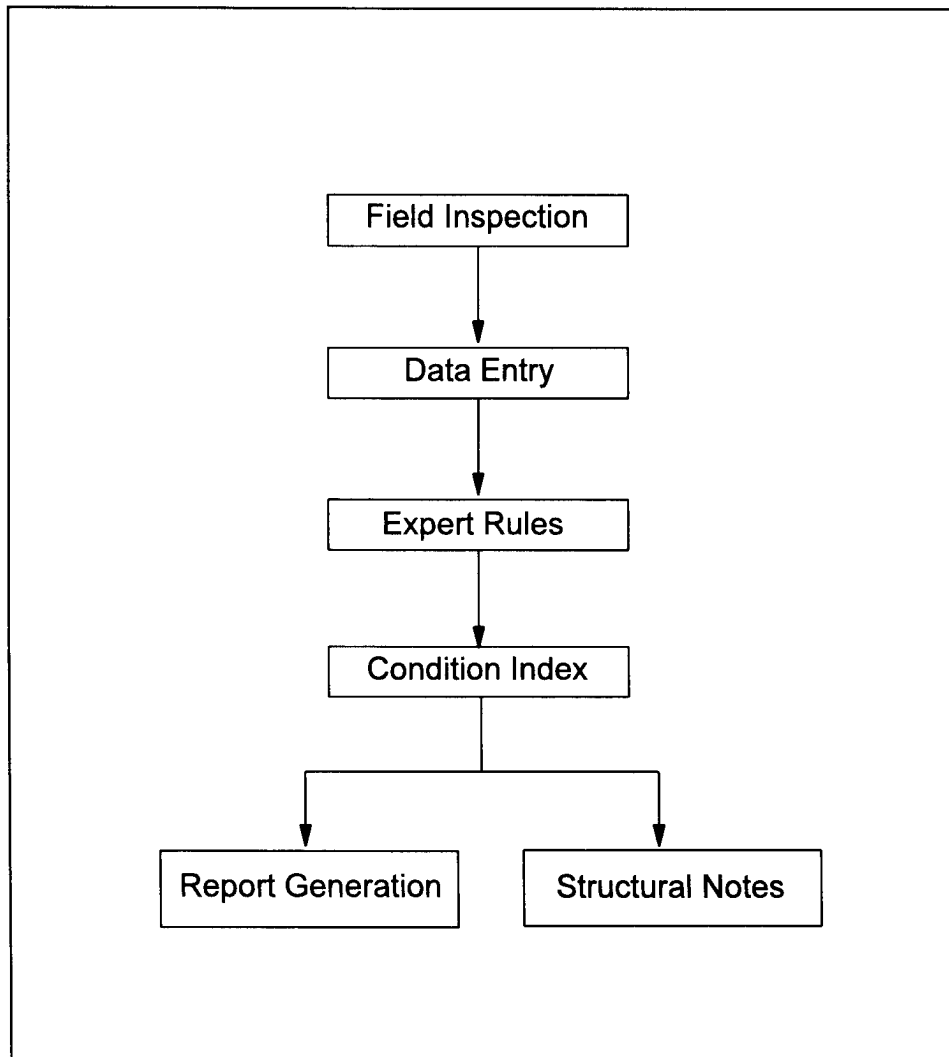
The inspection and rating procedure is illustrated schematically in Figure 1. The entire process is based on a field inspection of the operating equipment.

Figure 1. Inspection and rating procedure

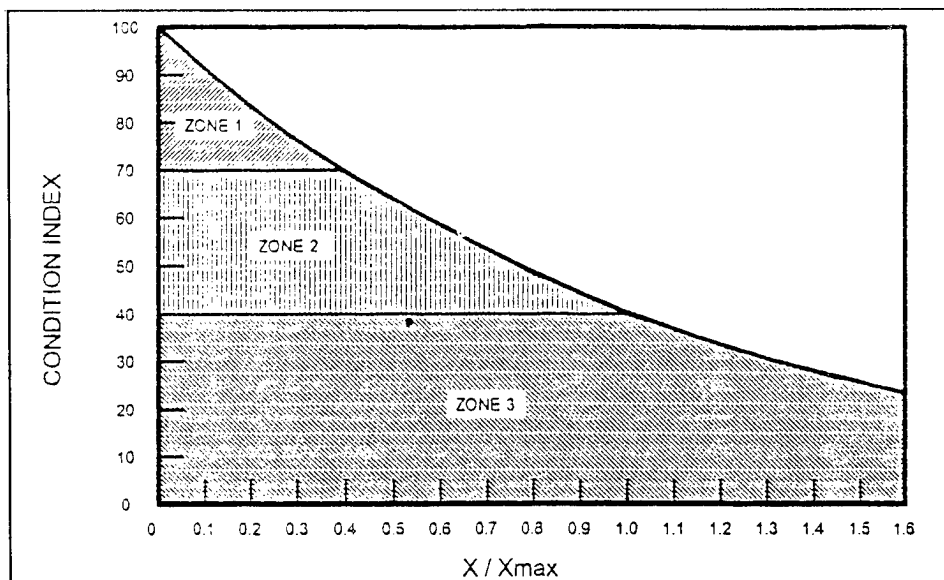
where  $X_{MAX}$  is some limiting value of X. Figure 2 illustrates the equation and the previously mentioned zones (Table 2). Experts selected  $X_{MAX}$  to be the point at which the operating equipment requires immediate repair or at least a more detailed inspection and CI evaluation. In other words, it corresponds to a CI of 40 and is a potentially hazardous situation.

Figure 2. Condition index related to  $X/X_{MAX}$ .

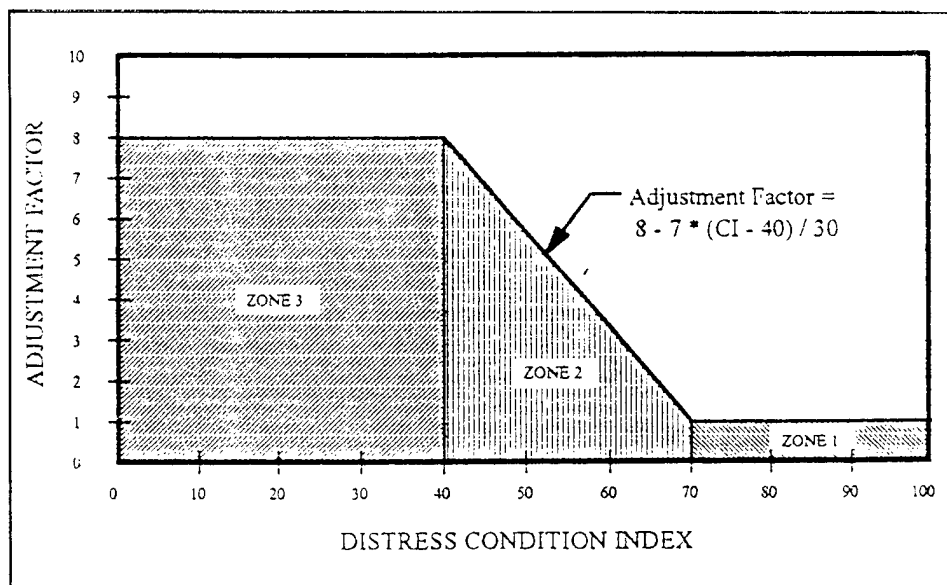
Figure 3 shows the value of the adjustment factor versus the  $CI_i$ .

Figure 3. Weight adjustment factor for condition index.

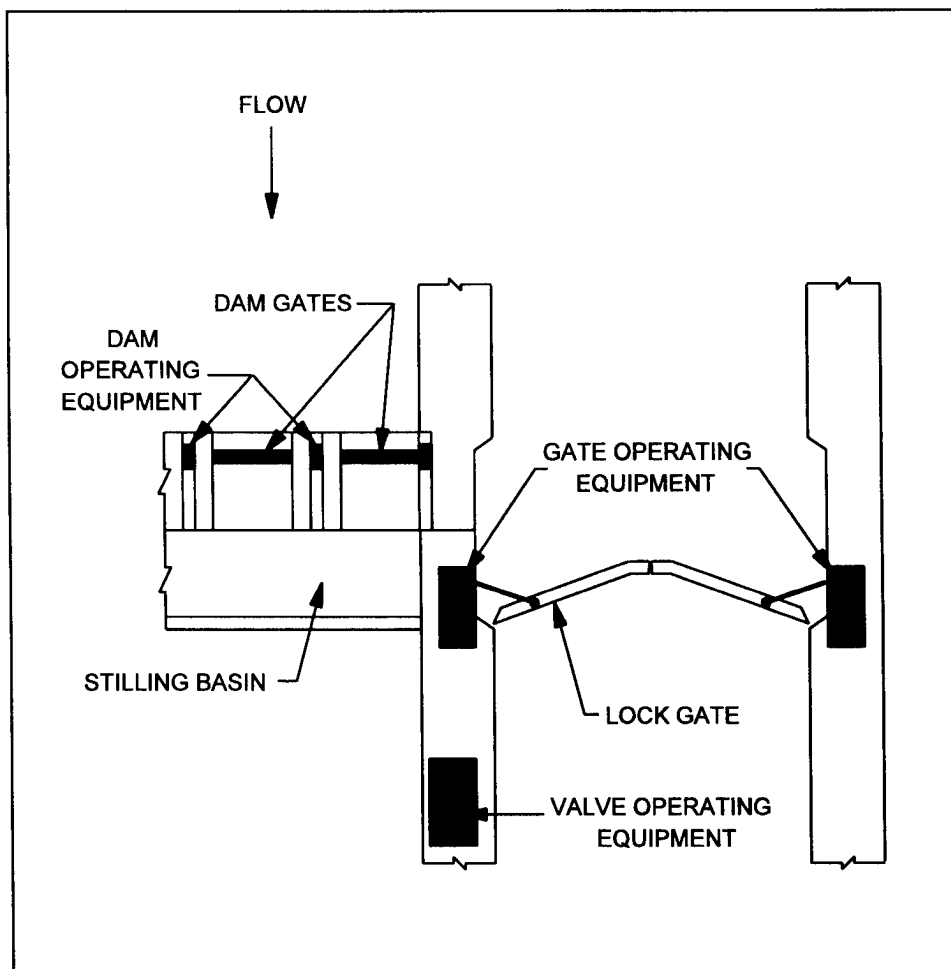
This chapter contains pages 1 and 2 of the inspection forms for: (1) lock gate, (2) valve, and (3) dam gate operating equipment. The side-by-side arrangement of the opposing pages displays specific explanations (right side) adjacent to the entry on the inspection form (left side). The chapter begins with a brief description of lock gates, valves, and dam gates. An overall view of a lock and dam facility is shown in Figure 4, in which various operating equipment areas are highlighted.

Figure 4. Lock and dam schematic.

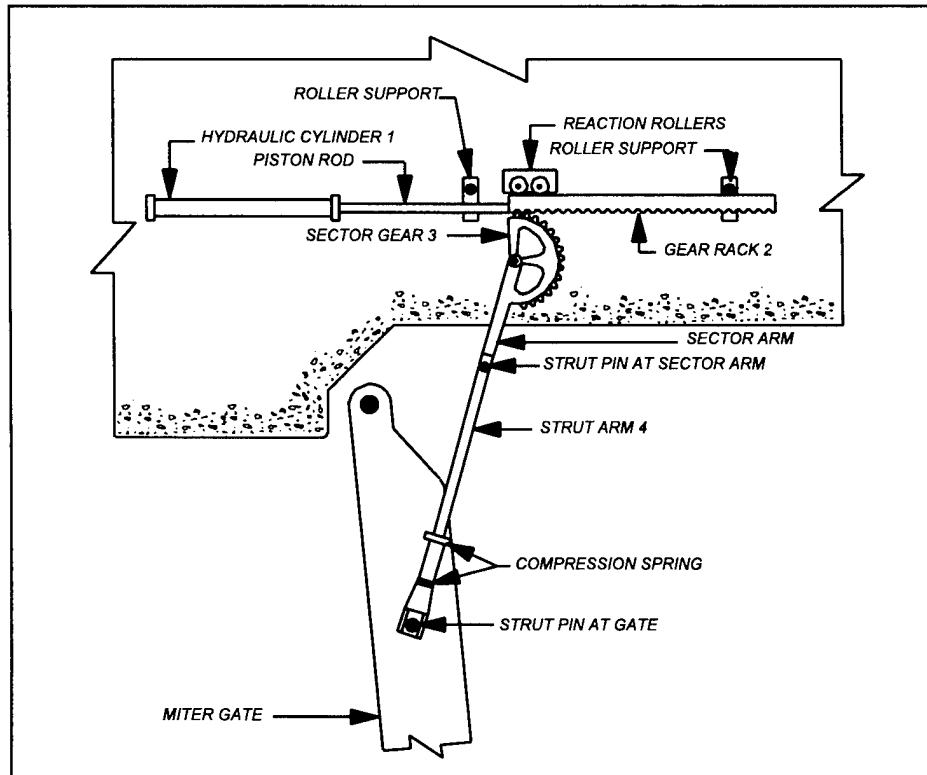
The appropriate inspection Parts 1 and 2 for the selected assemblies will then be completed and combined with pages 1 and 2 for a complete set of inspection forms. If the gate shown in Figure 5 were inspected, one hydraulic cylinder Parts 1 and 2, one gear rack Parts 1 and 2, one exposed gear Parts 1 and 2, and one strut page must be added to the pages 1 and 2 for a complete set.

Figure 5. Plan view of miter lock gate operating equipment.

The rack consists of a set of teeth arranged in a linear or slightly curved fashion. Teeth on the rack mesh with matching teeth on the corresponding gear. The rack transfers force from the hydraulic cylinder to the sector gear when used to operate a miter gate (Figure 5). When used to operate a sector gate, the rack is attached rigidly to the top of the gate and transfers force from a gear to the gate (Figure 8). Racks are sometimes designed to perform as strut and rack assemblies simultaneously. These rack/strut members are used to operate sector lock gates and tainter dam gates.

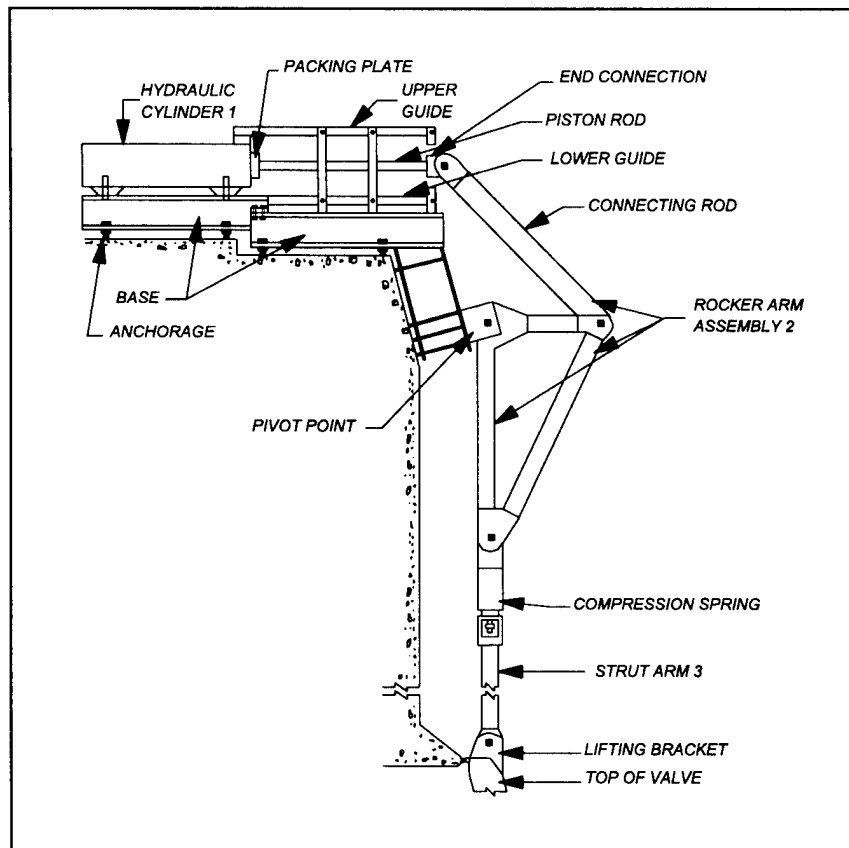
The appropriate inspection pages for the selected assemblies will then be completed and combined with pages 1 and 2 for a complete set of inspection forms. If the valve shown in Figure 6 were inspected, one hydraulic cylinder Parts 1 and 2, one rocker arm page, and one strut arm page must be added to pages 1 and 2 for a complete set.

Figure 6. Side view of tainter valve operating equipment.

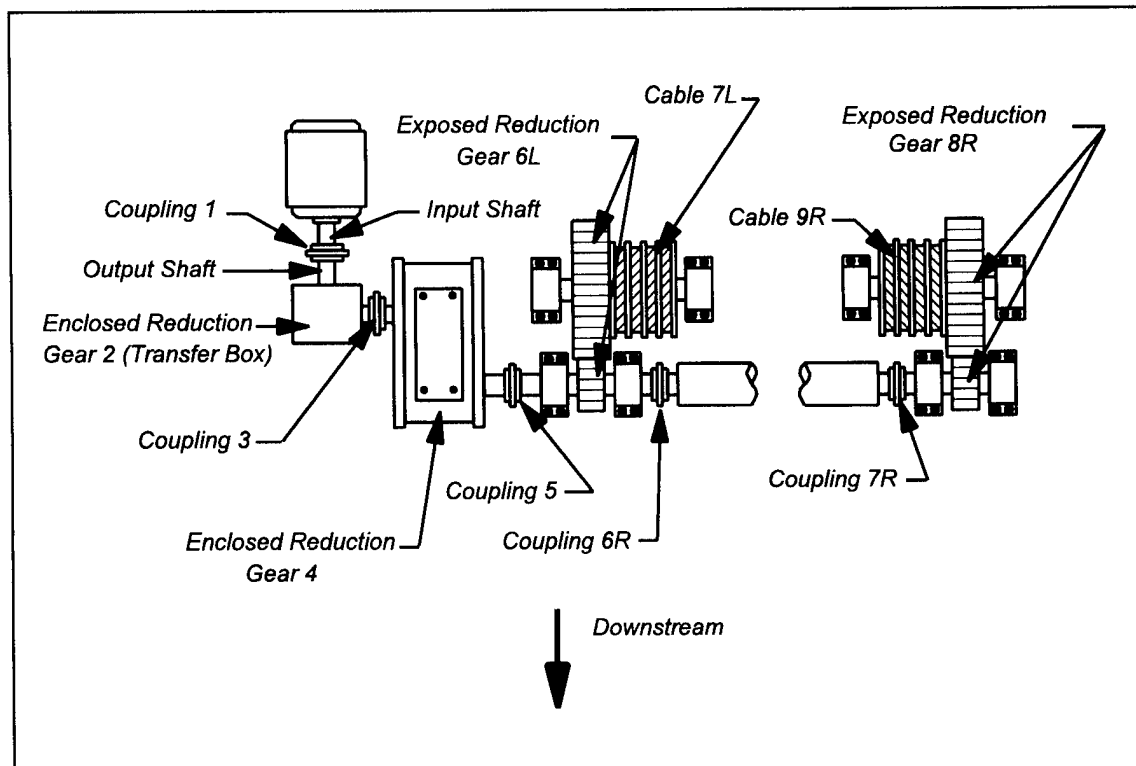
The appropriate inspection Parts 1 and 2 for the selected assemblies will then be completed and combined with pages 1 and 2 for a complete set of inspection forms. If the dam gate operating equipment shown in Figure 7 were inspected, five coupling pages, two enclosed gear Parts 1 and 2, two exposed gear Parts 1 and 2, and two cable Parts 1 and 2 must be added to pages 1 and 2 for a complete set.

Figure 7. Plan view of dam gate operating equipment.

Reduction gears are a series of gears used to lessen the torque required to open and close or raise and lower gate or valve structures, respectively. As a result, the structure moves at a slower rate of speed than the motor rotates (Figures 7 and 8). Enclosed reduction gears are in a gear box and can sometimes be seen by removing the cover plate. The gears in the gear box are lubricated with an oil or grease bath.

The transfer box is a set of reduction gears that redirects the rotating shaft by 90 degrees (Figure 7). This is accomplished with the use of a worm and a worm gear (Figure 9) or with bevel gears.

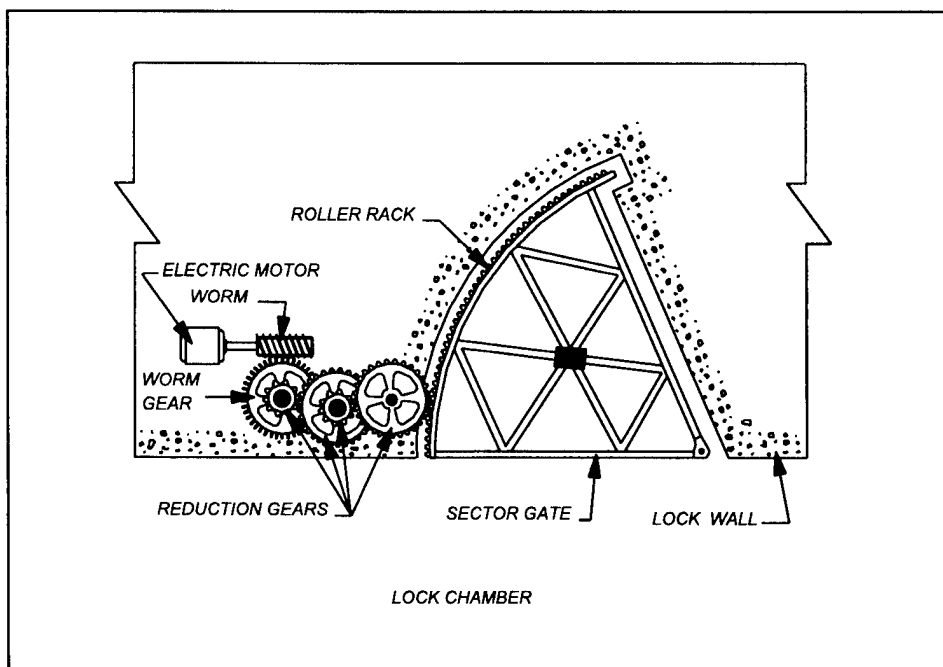
Figure 8. Plan view of sector lock gate operating equipment (gear and rack).

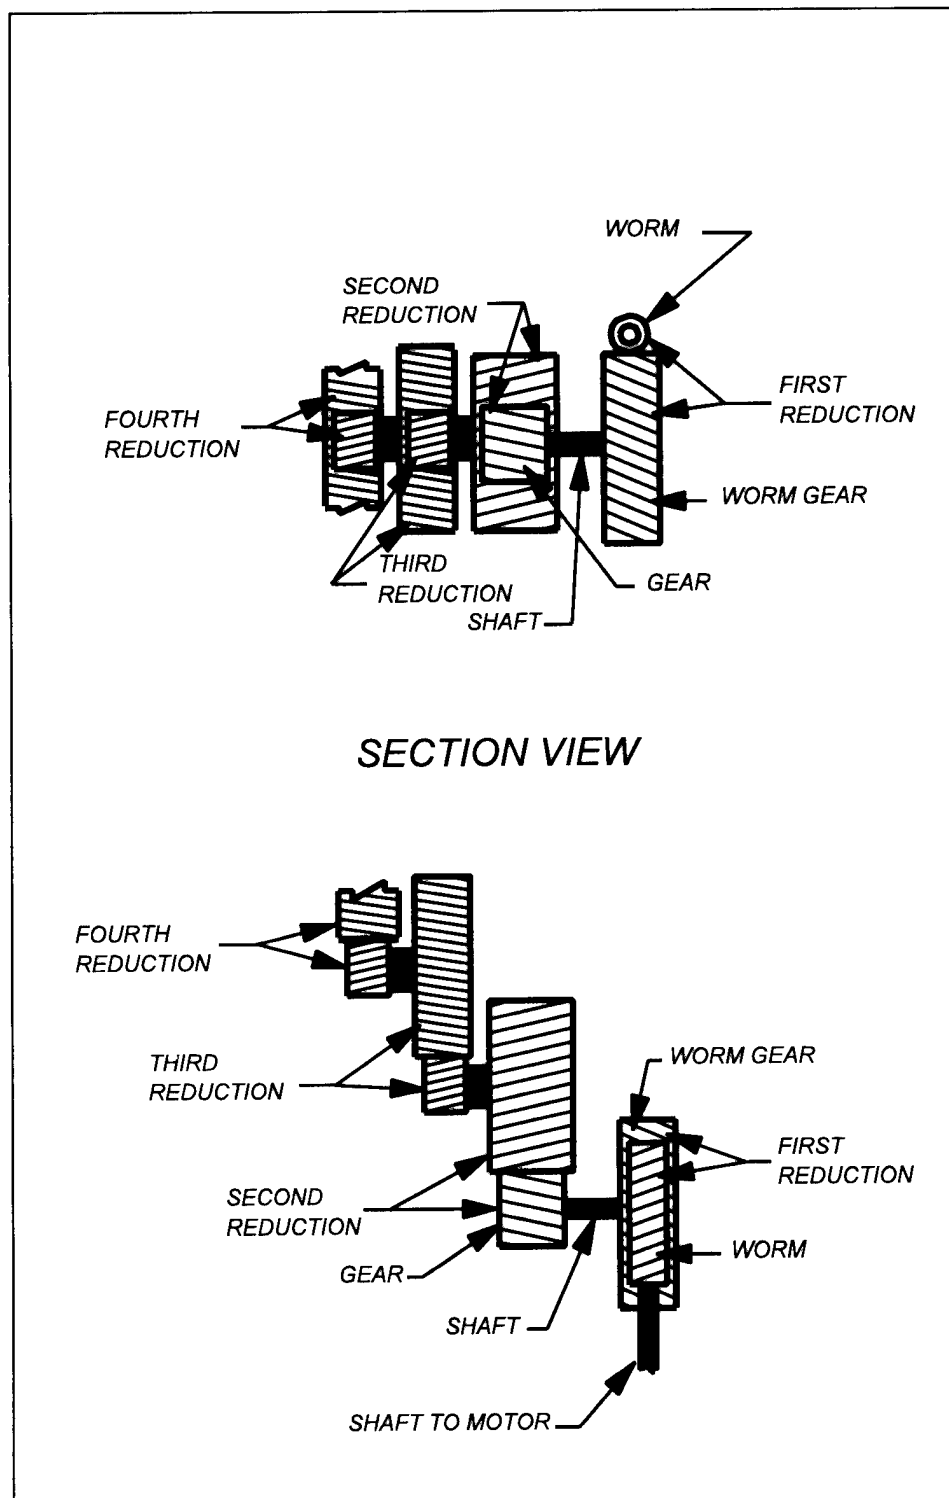
Figure 9. Reduction gear schematic.

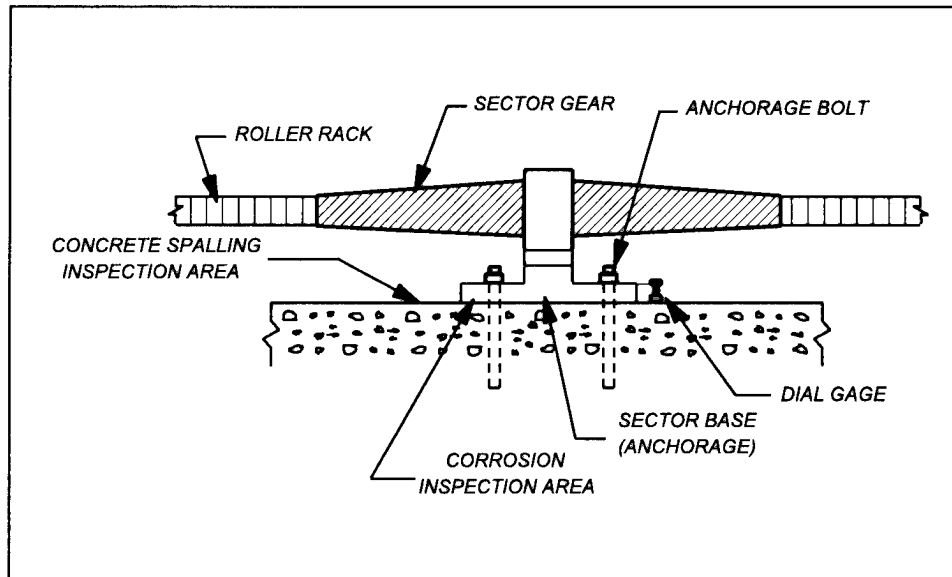
Figure 10. Gear anchorage movement/deterioration measurement.

Record the evidence of MOVEMENT of the gear ANCHORAGE system base of the gear as the gate is opened and closed. Evidence of movement can be observed visually or enhanced by placing a dial gage to monitor any movement (Figure 10). A dial gage change greater than 0.002 in. is considered movement. Excessive concrete spalling may indicate a displacement occurred at this location at some time. Also, record the presence of any CORROSION (10% volume loss) of the steel portion or any CRACKED CONCRETE at the interface of the embedment (Figure 10). Small hairline cracks, probably caused by thermal expansion or contraction of the concrete, should be ignored. Indicate if there are any CORRODED (10% volume loss), MISSING OR BROKEN, or LOOSE NUTS at the gear anchorage if the BOLTS are EXPOSED (Figure 10).

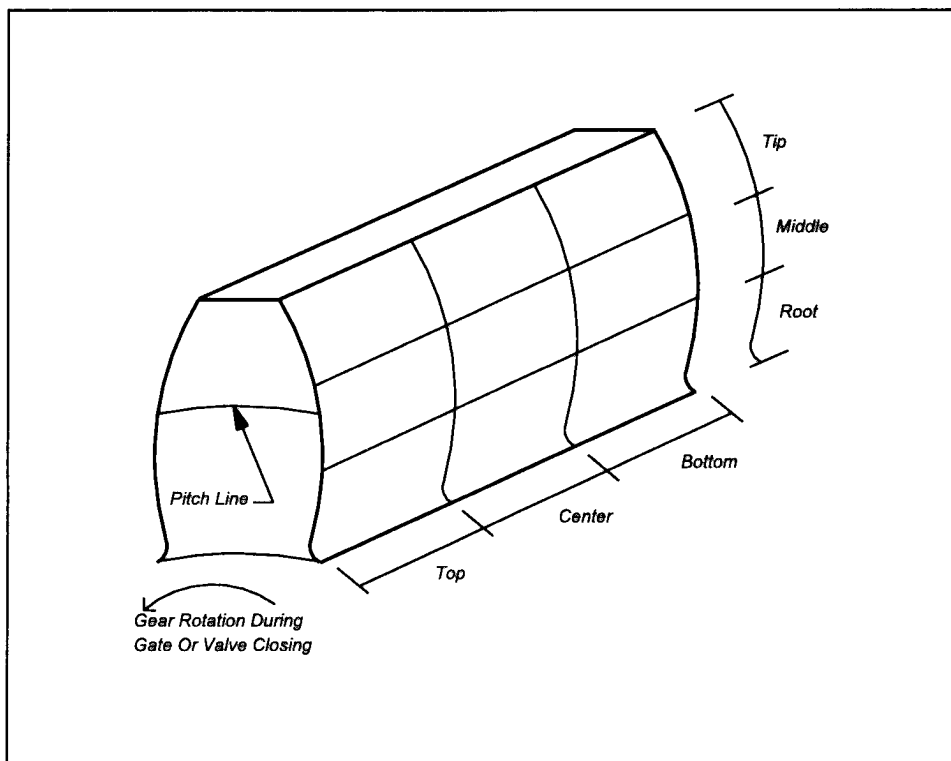
Figure 11. Tooth contact location.

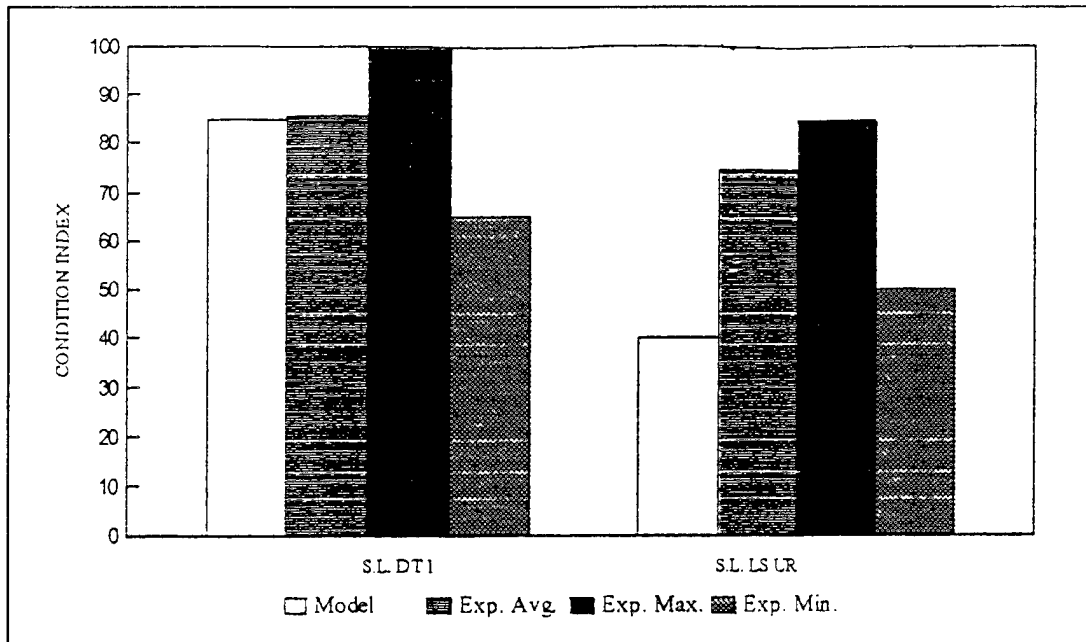
Twenty exposed gear assemblies were observed during the field tests. The bar charts in Figures 12, 13, and 14 compare the experts' subjective CI during the various field tests with the CI calculated from the rules in Section 4.3 for three exposed gear distresses. Assemblies with no distresses are not plotted. Comparisons between the calculated and experts' CIs are summarized in the remainder of this chapter.

Figure 12. Anchorage movement/deterioration: exposed gear assembly.

### Anchorage Movement/Deterioration: Figure 12

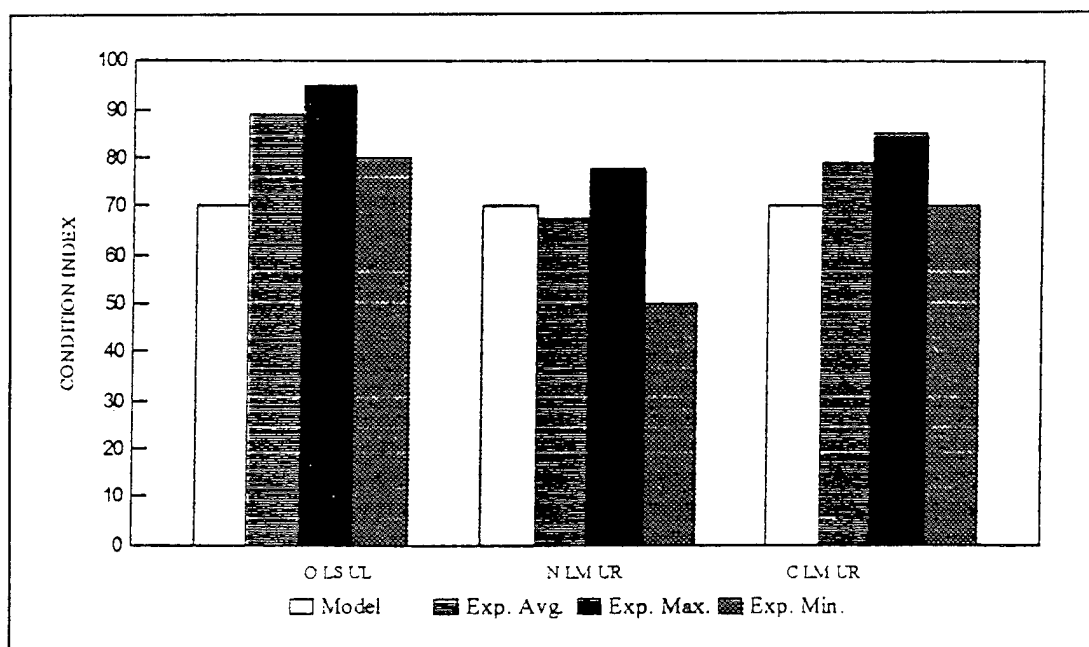
Figure 13. Bearing/bushing wear: exposed gear assembly.

### **Bearing/Bushing Wear: Figure 13**

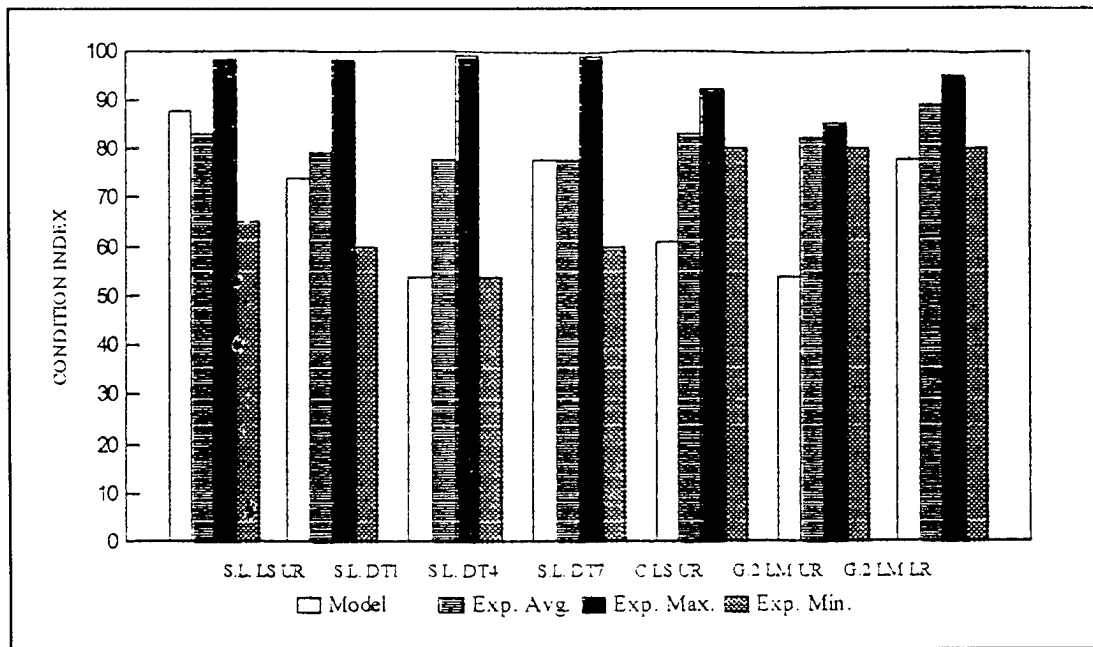
Figure 14. Reduced tooth contact: exposed gear assembly.

### **Reduced Tooth Contact: Figure 14**

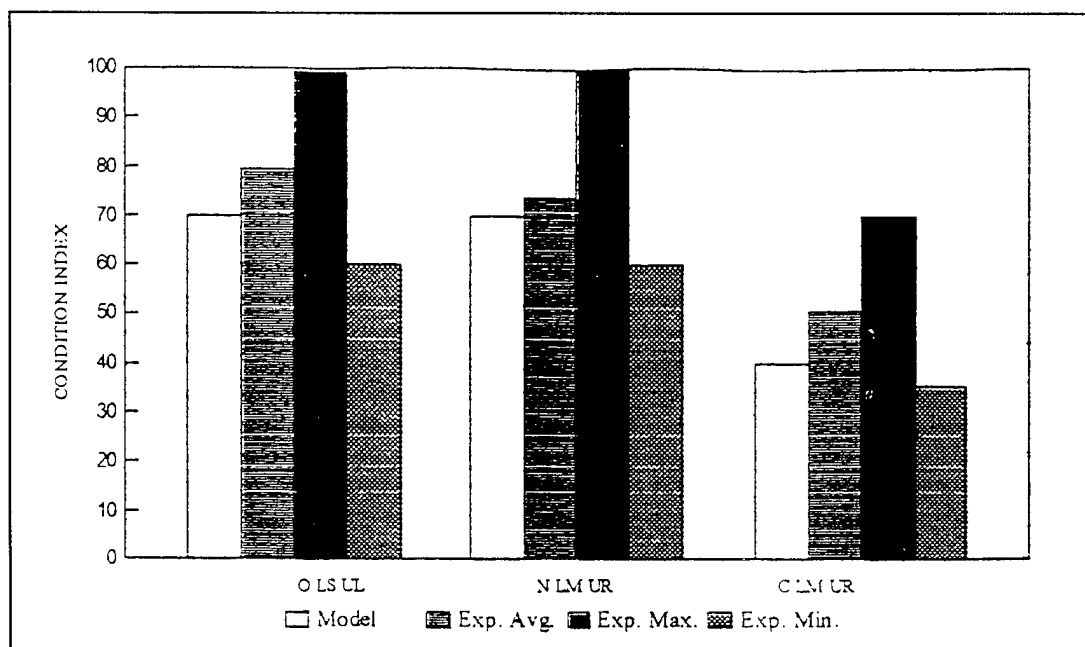
The calculated noise, jumping, and vibration CIs closely approximated the experts' averages. In 12 of the 15 observed exposed gear assemblies, this distress was not observed; therefore, the calculated CIs were 100 and the experts' average CIs were above 90. In one case (Upper Right Lock Gate Moore Haven), a thumping noise was heard in the gear box. The calculated CI was 70, while the experts' average CI was 80. In another case, jumping was observed (Upper Right Lock Gate St. Lucie); therefore, the calculated CI was 70. The experts' average CI was 74. The enclosed gear used to operate Dam Gate #1 on the St. Lucie Dam was observed to make a noise and vibrate. The calculated CI for noise and vibration is 40. The experts' average CI dropped to 51.

Figure 16. Noise, jumping, and vibration: enclosed gear assembly.

Fifteen enclosed gear assemblies were observed during the field tests. The bar charts in Figures 16 to 21 compare the experts' subjective CI to the CI calculated from the rules in Section 5.3 for six enclosed gear distresses that were observed during field tests. Comparisons between the calculated and experts' CIs are summarized below.

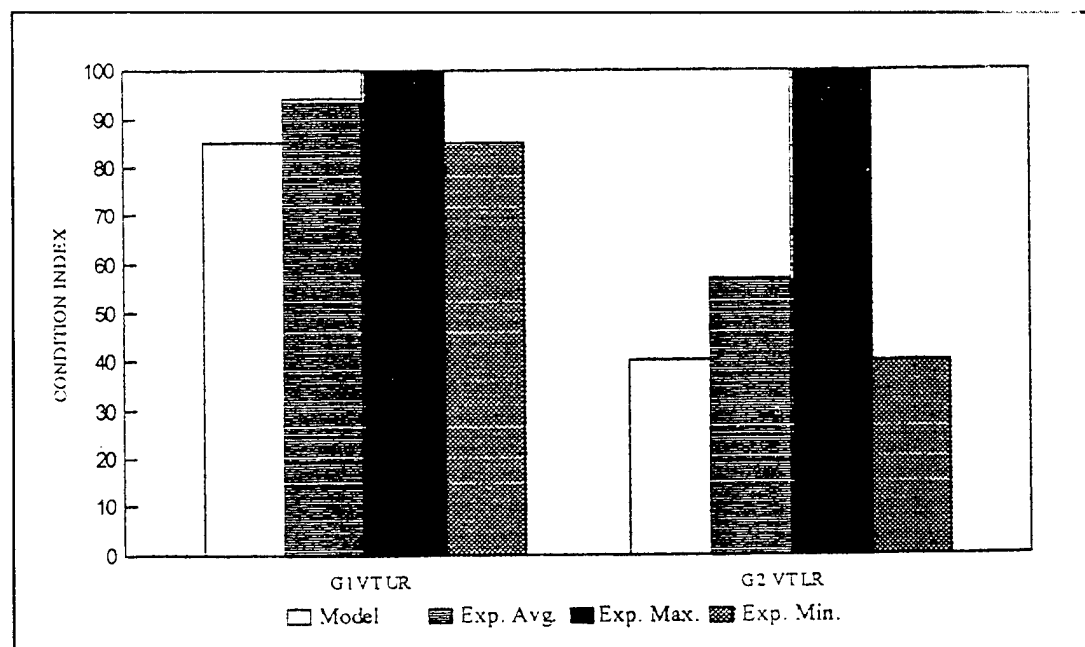
Figure 17. Anchorage movement/deterioration: enclosed gear assembly.

### **Anchorage Movement/Deterioration: Figure 17**

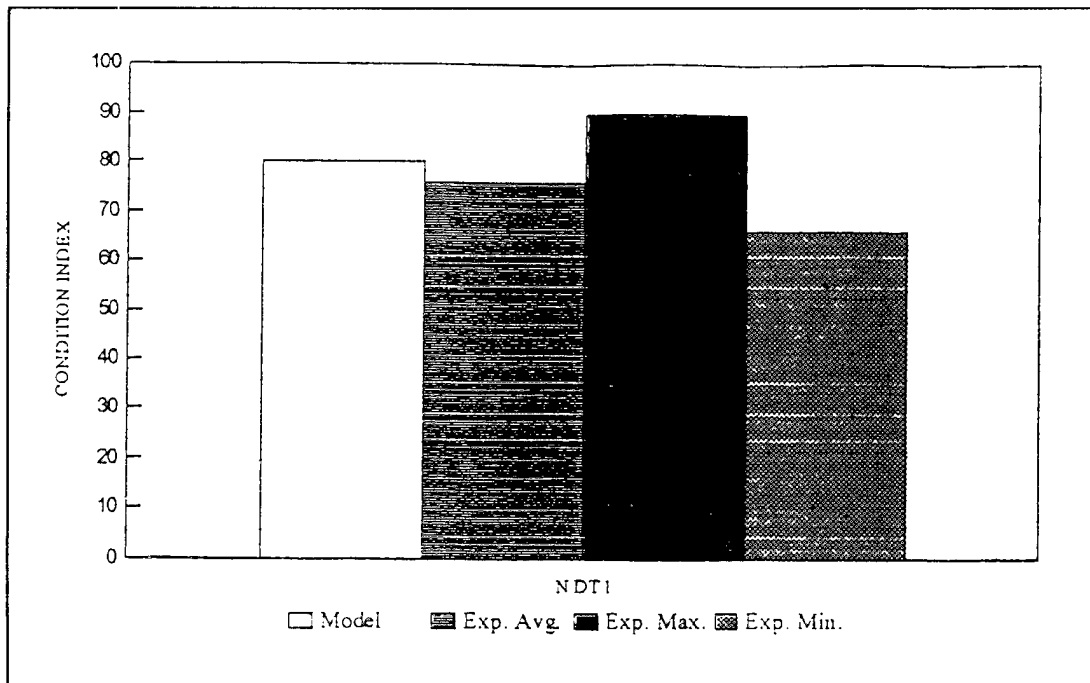
Figure 18. Damaged teeth: enclosed gear assembly.

### **Damaged Teeth: Figure 18**

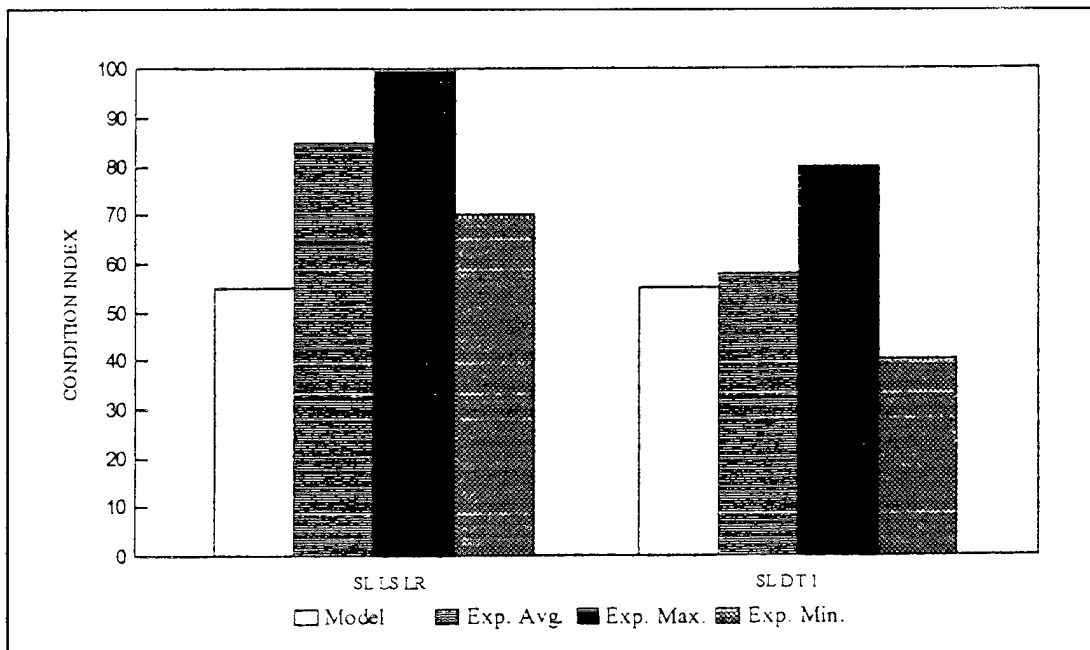
Figure 19. Temperature rise of oil: enclosed gear assembly.

### **Temperature Rise Of Oil: Figure 19**

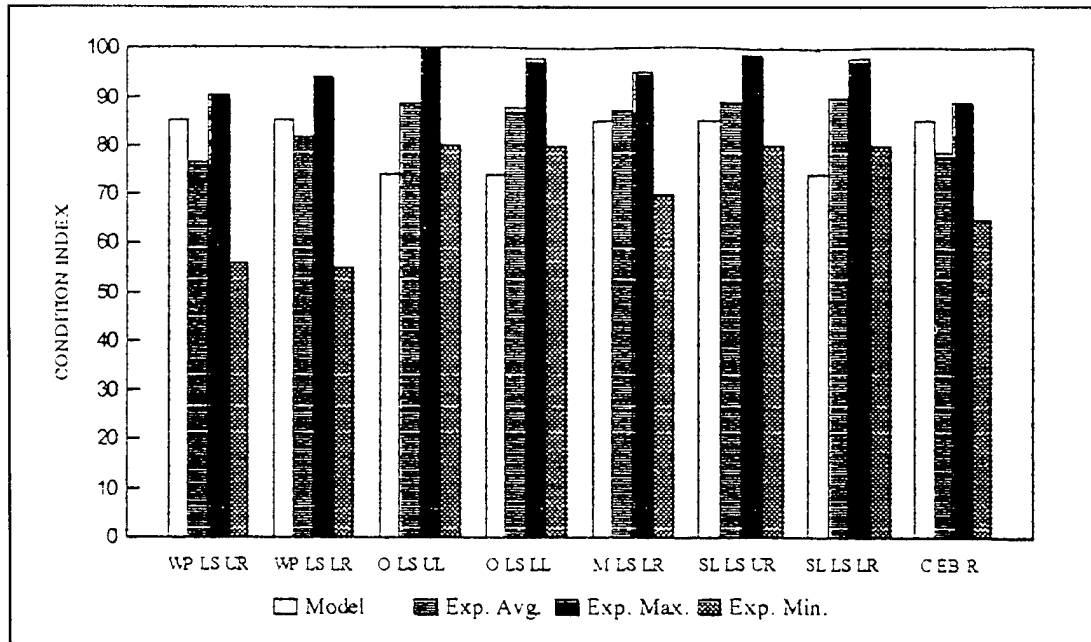
Figure 20. Oil leakage: enclosed gear assembly.

### **Oil Leakage: Figure 20**

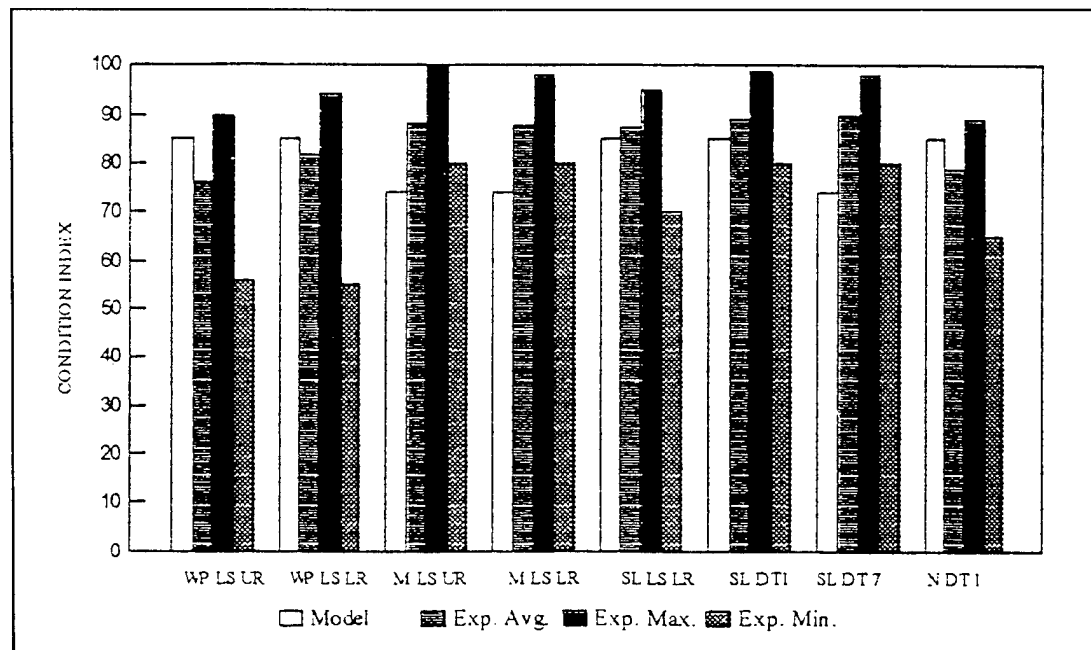
Figure 21. Oil contamination: enclosed gear assembly.

### Oil Contamination: Figure 21

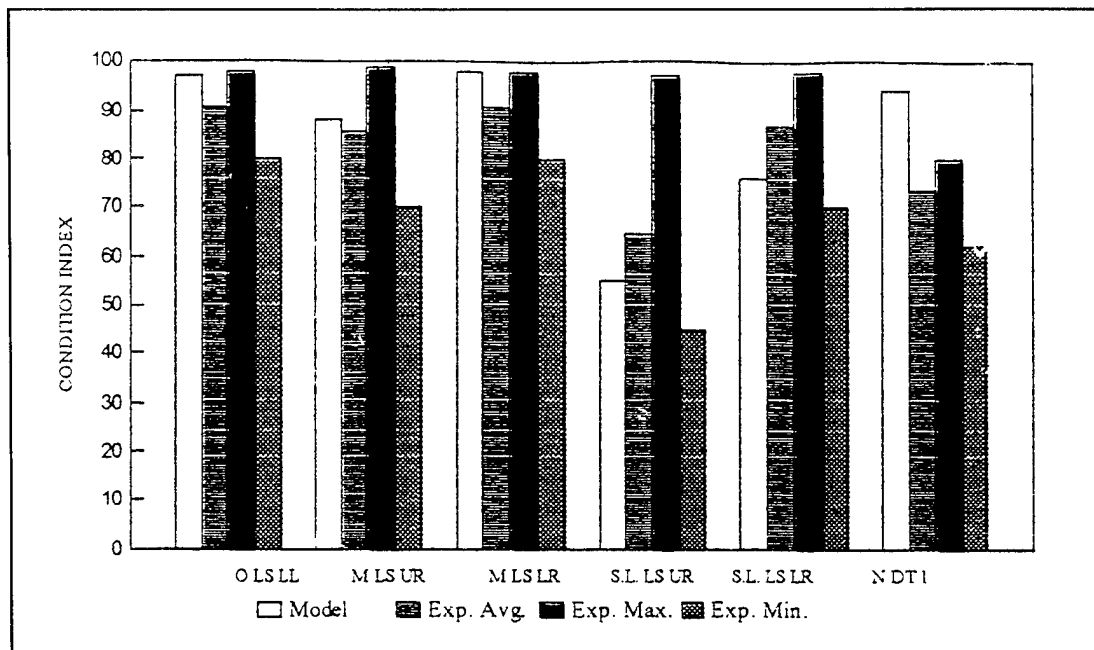
The assembly CI for the enclosed gear assembly was calibrated for six assemblies. For four of the assemblies, the model CIs were above the experts' average CIs, and for the remaining two assemblies the model CIs were slightly lower. In only one case (Tainter Dam Gate #1 Newburgh) was the model CI significantly different from the experts' average CI. The corresponding model CIs and experts' average CIs were in the same zone for each of the six calibrated assemblies.

Figure 22. Enclosed gear assembly.

### Assembly CI: Figure 22

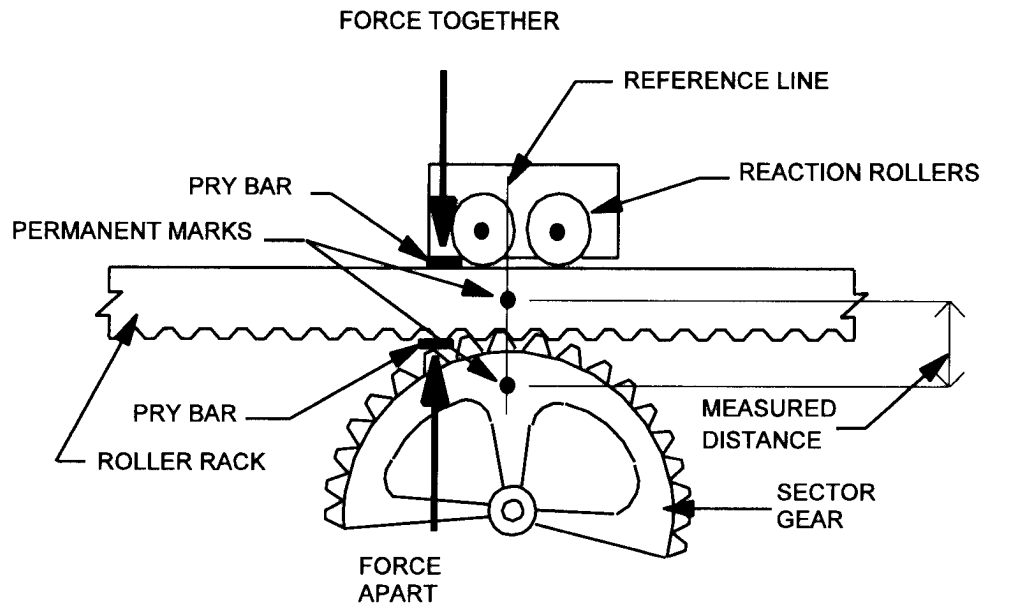
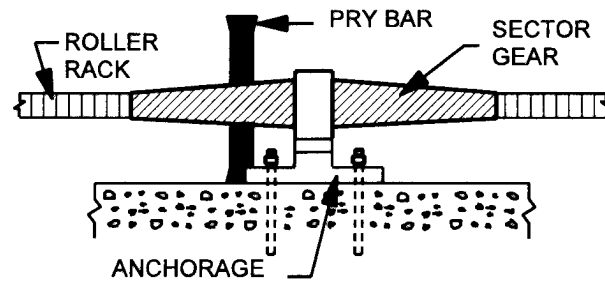
### PLAN VIEW

FIRST FORCE APART  
THEN FORCE TOGETHER

JACK OR PRY BAR  
MAY BE USED

### SECTION VIEW

Figure 23. Gear/rack displacement measurement.

Excessive lateral DISPLACEMENT of the ROLLER RACK is an indication that a problem is developing in the equipment. The movement can be quantified by placing permanent marks on the gear and rack (Figure 23). The distance between these two points is recorded when the gear and rack are JACKED or pried APART and when JACKED or pried TOGETHER. The pry bar is placed between the gear and the rack to force the roller rack and gear apart and the first measurement is taken (Figure 23). A jack can also be placed in a position to force the gear and roller rack apart. The second measurement is taken after the pry bar or jack are placed on the opposite side and used to force the gear and roller rack together. These measurements should be taken when the gate is OPEN and CLOSED. The difference between these two measurements indicates the "play" in the system. This measurement is not applicable to racks attached to sector gates.

**Measurement and limits.** Measurements are recorded when the rack is moved to the right and left with a crow bar (pry bar) or a jack (Figure 23).

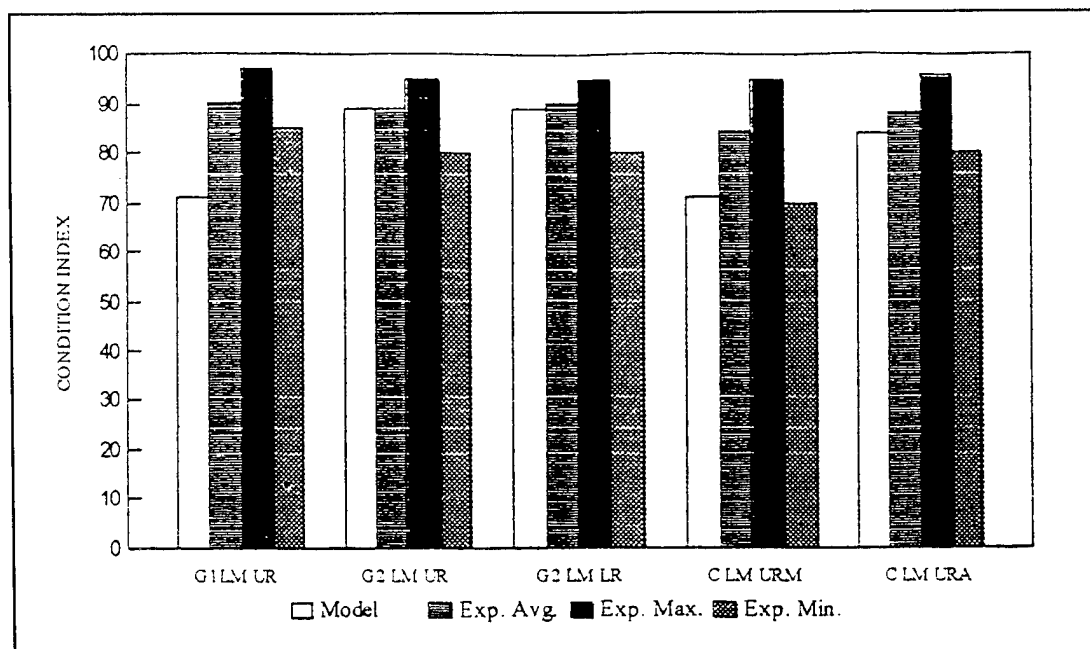
Figure 24. Reduced tooth contact: gear rack assembly.

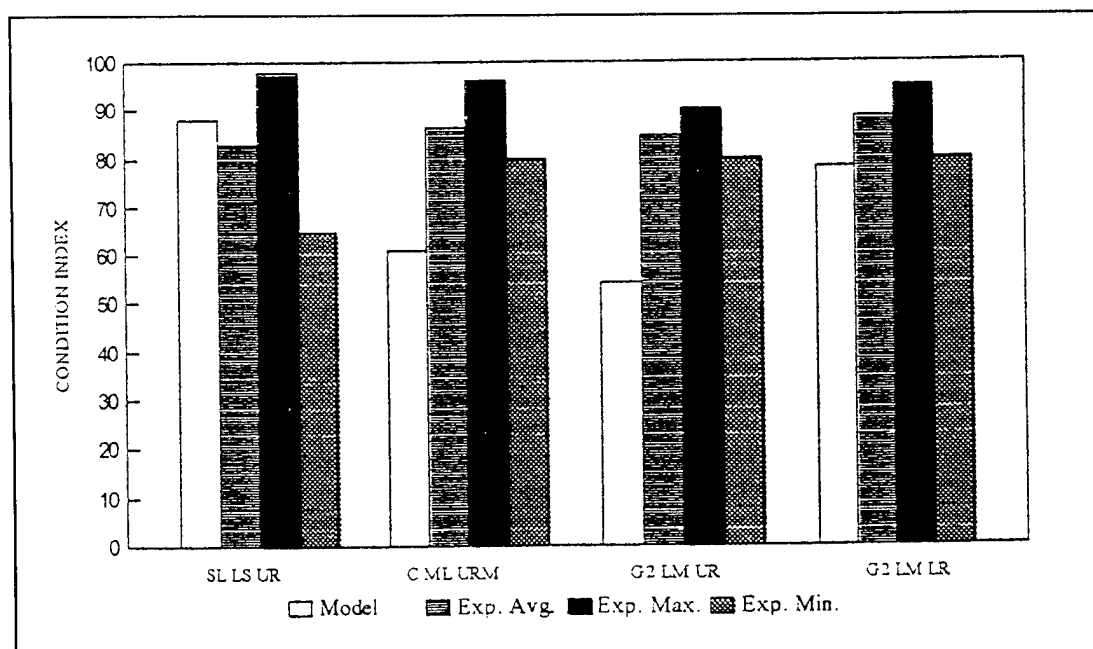
Figure 25. Gear/rack displacement: gear rack assembly.

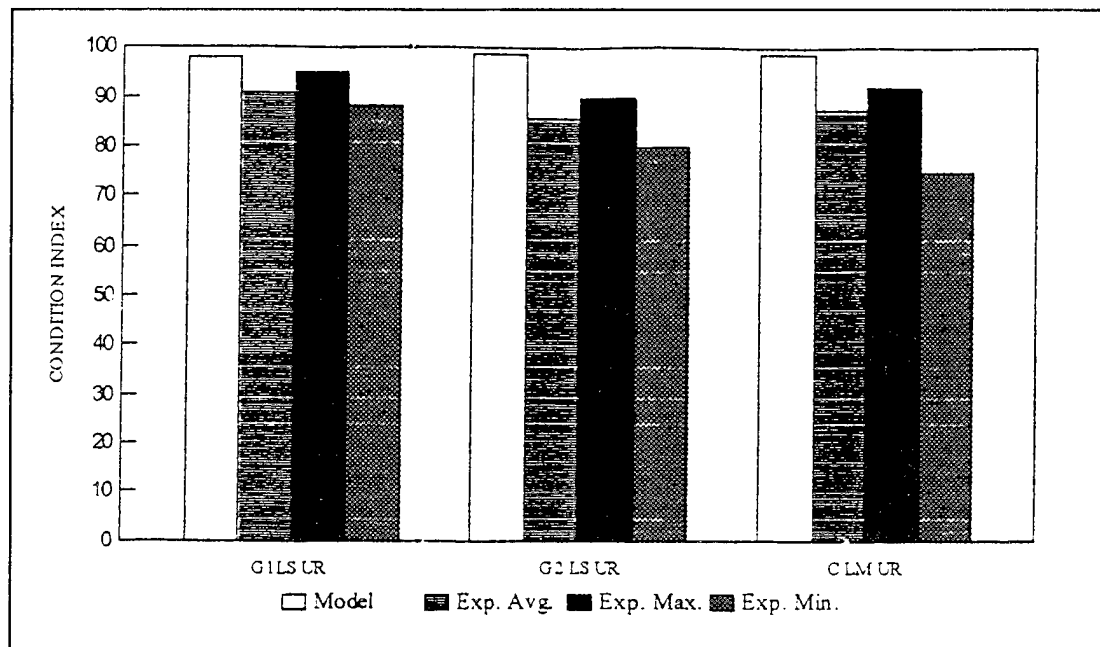
The assembly CI for the rack assembly was calibrated for three assemblies. In each case the model CI was slightly higher than the experts' average CI. Although the model CIs were higher, the experts' average CIs and the model CIs were all in the upper part of Zone 1.

Figure 26. Gear rack assembly CI.

### Assembly CI: Figure 26
